NATIONAL TRANSPORTATION SAFETY BOARD

**SYSTEMS GROUP CHAIRMAN FACTUAL REPORT ADDENDUM FOR
ELECTRICAL SHORT CIRCUIT/ARCING OF AGED AIRCRAFT WIRING**

A. ACCIDENT: DCA96MA070

Report No. N191-RPT4AU99

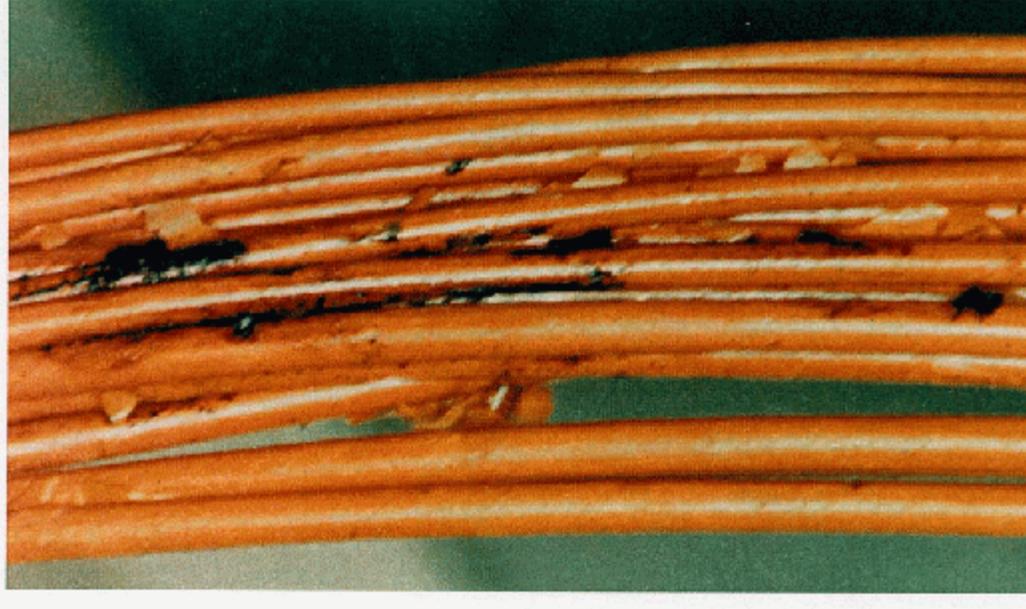
One of these aspects is the wet arc tracking of the wire. On aircraft, liquids do get onto wires for a variety of reasons: spilled beverages, leaking lavatory water, condensation, or moisture absorbed into salt or other surface contaminants. This can lead to carbon tracking which is a process where a conducting carbon path is slowly built up over time due to low level electrical discharges on the surface of the wire. Figure 1 shows an example of carbon build up on 81381 type wires. This carbon build up can lead to arcing.

Figure 1. A bundle of Mil-W-81381 wire with visible carbon tracking .

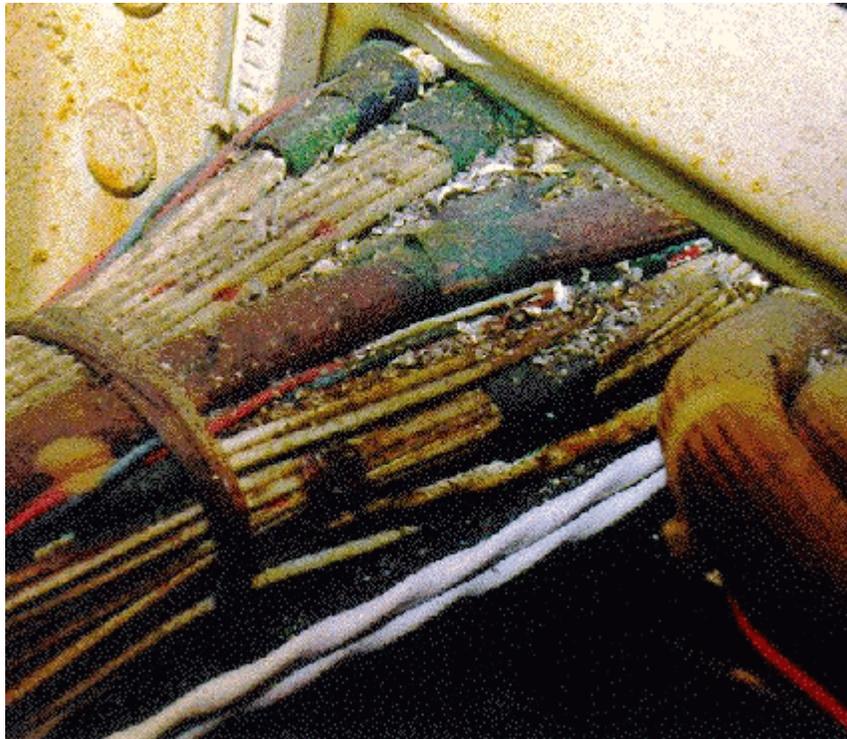
Another potential issue is metal drill shaving on and in wire bundles and the potential for mechanical damage to the insulation. The Safety Board investigation documented numerous cases of metal shavings on wire bundles and between the wires of bundles. Figure 2 shows an example of this.

Figure 2. Metal drill shaving on a wire bundle of a commercial aircraft.

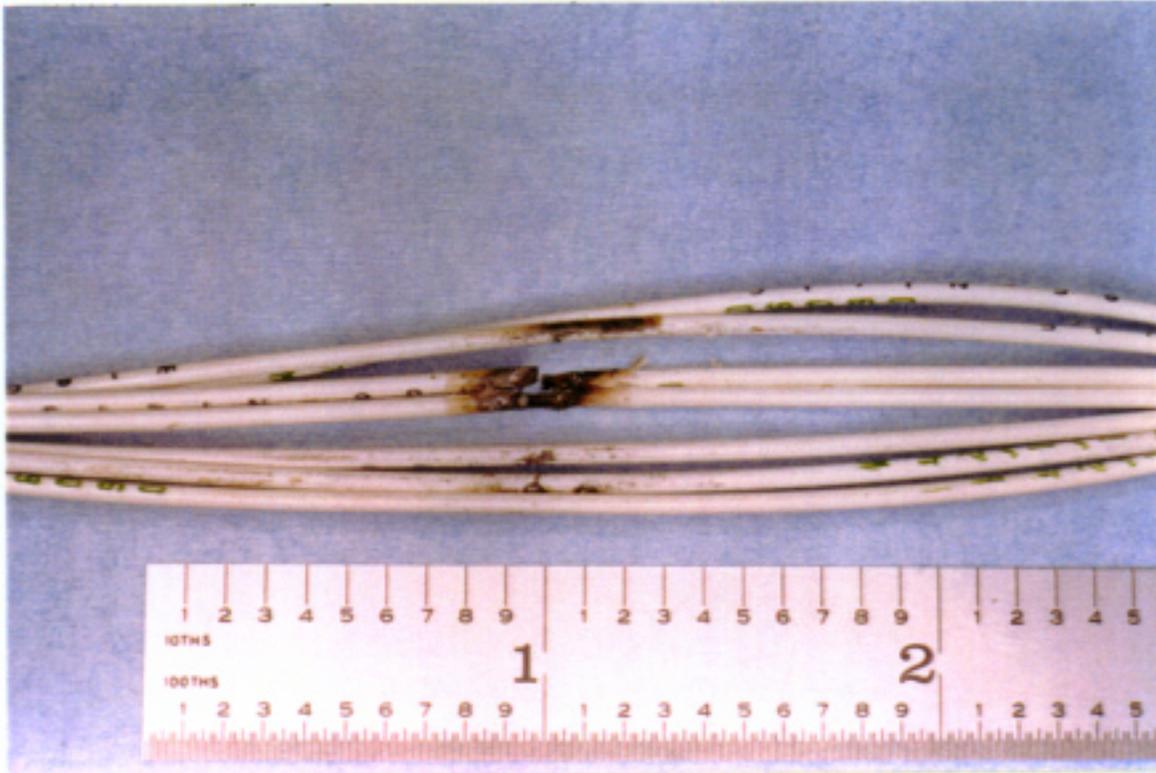
In test A the sample was very active for the first minute or so and then had periods of dormancy interrupted by short spurts of activity. Examination of the bundle shows damage and char for about ½ an inch around the pre-damaged cuts. Also, about 3/8 of the conductors of the top two wires had been eroded away (Figure 18).

Figure 18. Preliminary Test A: Bundle after wet arc track testing for 5 minutes.

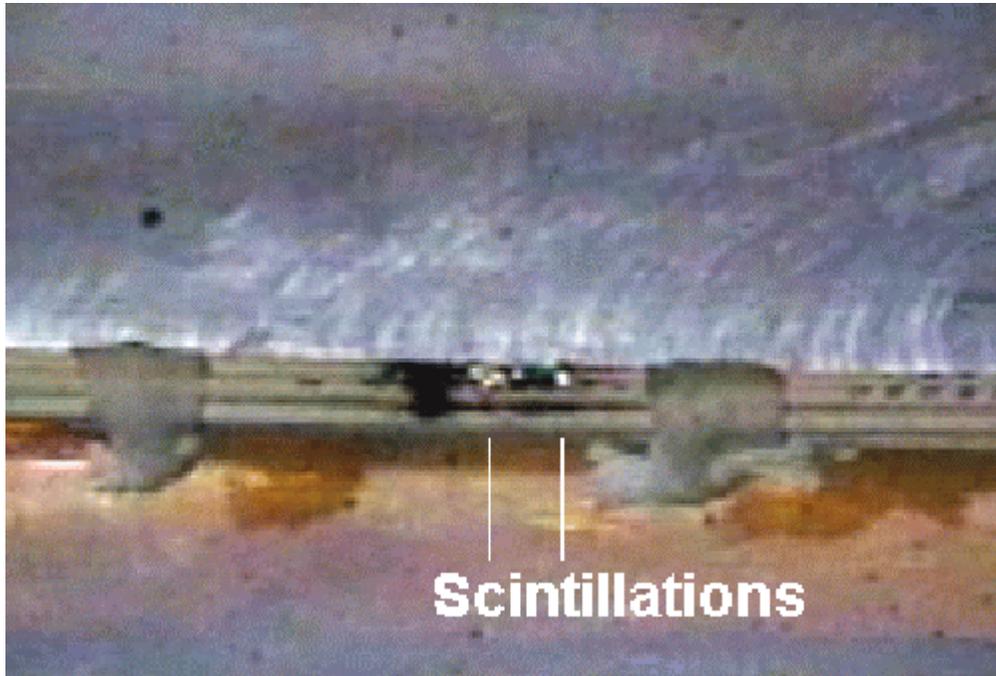
The results of Test 1 and Test 2 were similar to each other though Test 2 did become more active a little sooner than did Test 1. Visible scintillations began within the first minute of the tests. In a couple of minutes, a char path began to develop between the two pre-damaged cracks in the insulation and scintillations were observed along this path. This is shown in Figure 20.

Figure 20. Test 2: Scintillations along the built up char path.

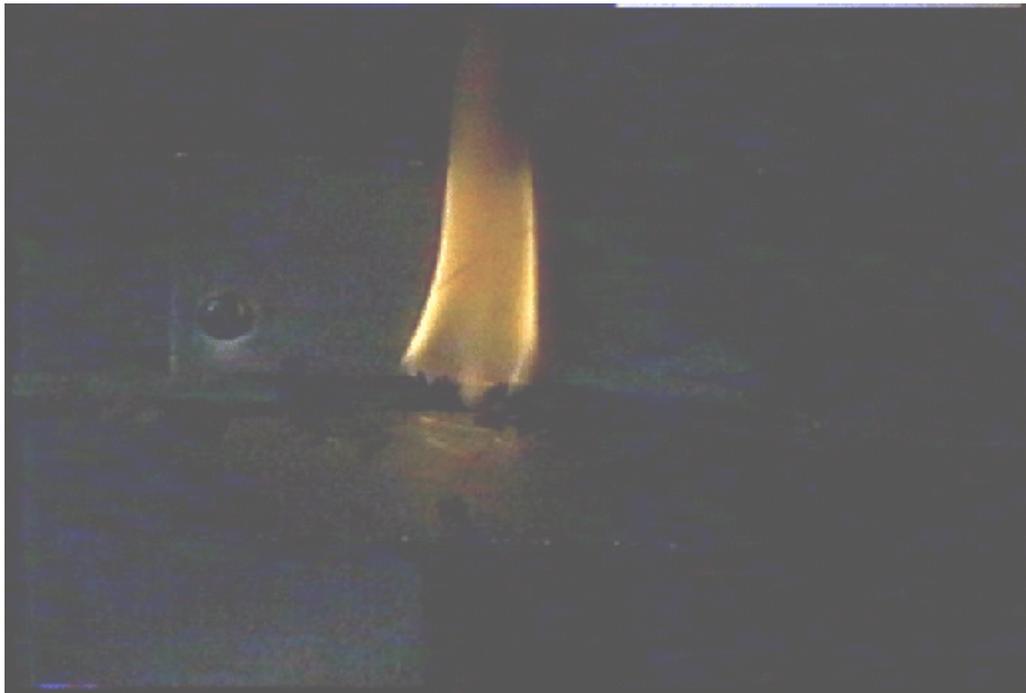
Figure 21. Test 2: A Chemical combustion flame observed after a series of flashing events.

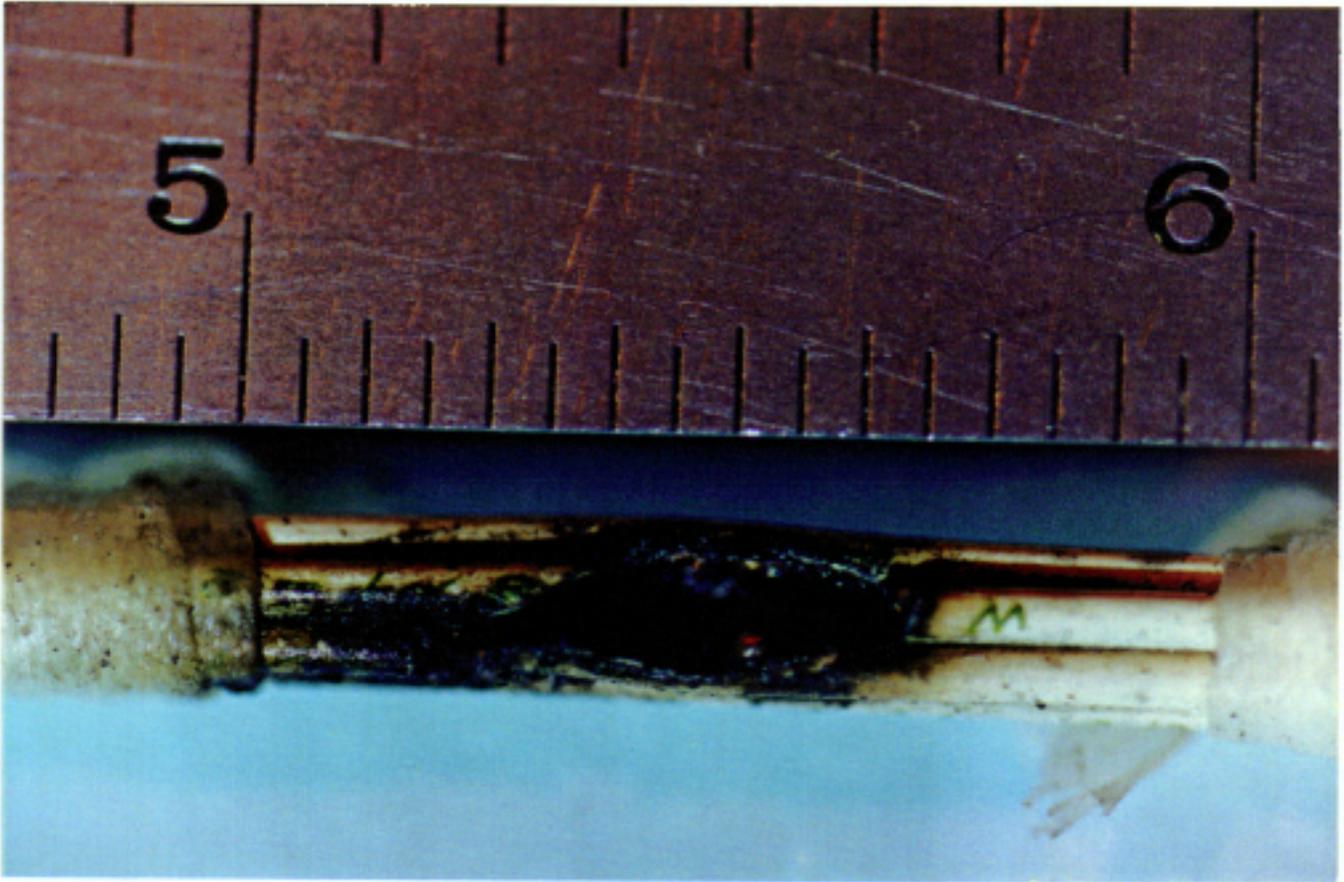
Examination of the bundles after the tests shows that the damage and char build up was over a 1/2 to 5/8 inch length of the wire bundle. In each test, the conductor of 2 (test 1) or 3 (test 2) of the wires were eroded away up to 1/2 of an inch. In test 1 the eroded conductors were from wire [A1] and wire [B2] (wire [B2] was not originally damaged but must have become damaged soon after the start of the test.). In each test, two of the five previously undamaged wires failed a wet dielectric test. Figure 23 shows the sample from Test 2 after being removed from the arc tracking apparatus.

Figure 23. Test 2: Sample bundle after 25 minutes of wet arc track testing.

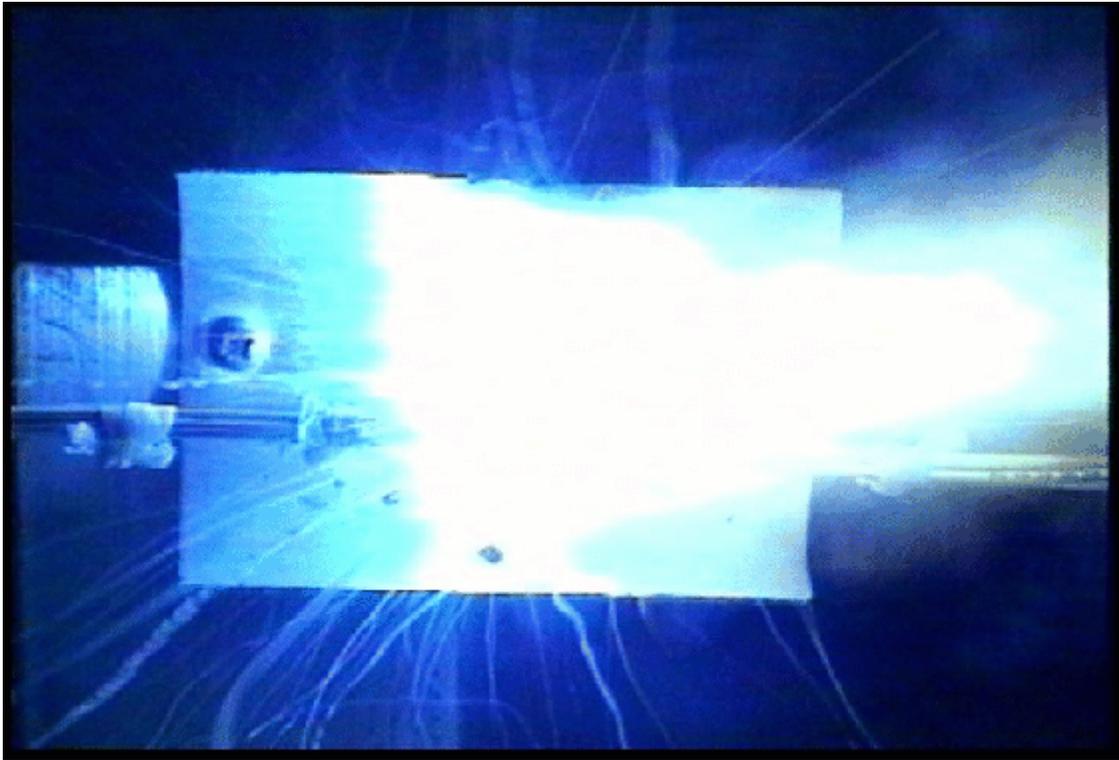
Scintillations were observed on the sample almost immediately after Test 3 was started. Several minutes in to the test, before a visible char track was developed a flash was observed. On the next drop of saline the sample burst into intense arcing that lasted less than a second and damaged all of the active wires in the bundle though no circuit breakers were tripped (Figure 24). The sample became dormant for about 30 seconds before another burst of arcing which did trip the circuit breaker in series with wire [C]. The arcing stopped and the sample was inactive for about 5 minutes. At this point the circuit breaker was reset and the bundle arced again. This time 3 circuit breakers [B1], [B2] and [C] were tripped and the arc stopped. The sample was then removed from the test apparatus.

Figure 24. Test 3: Strong arcing on a W42/1/1-20 Sample.

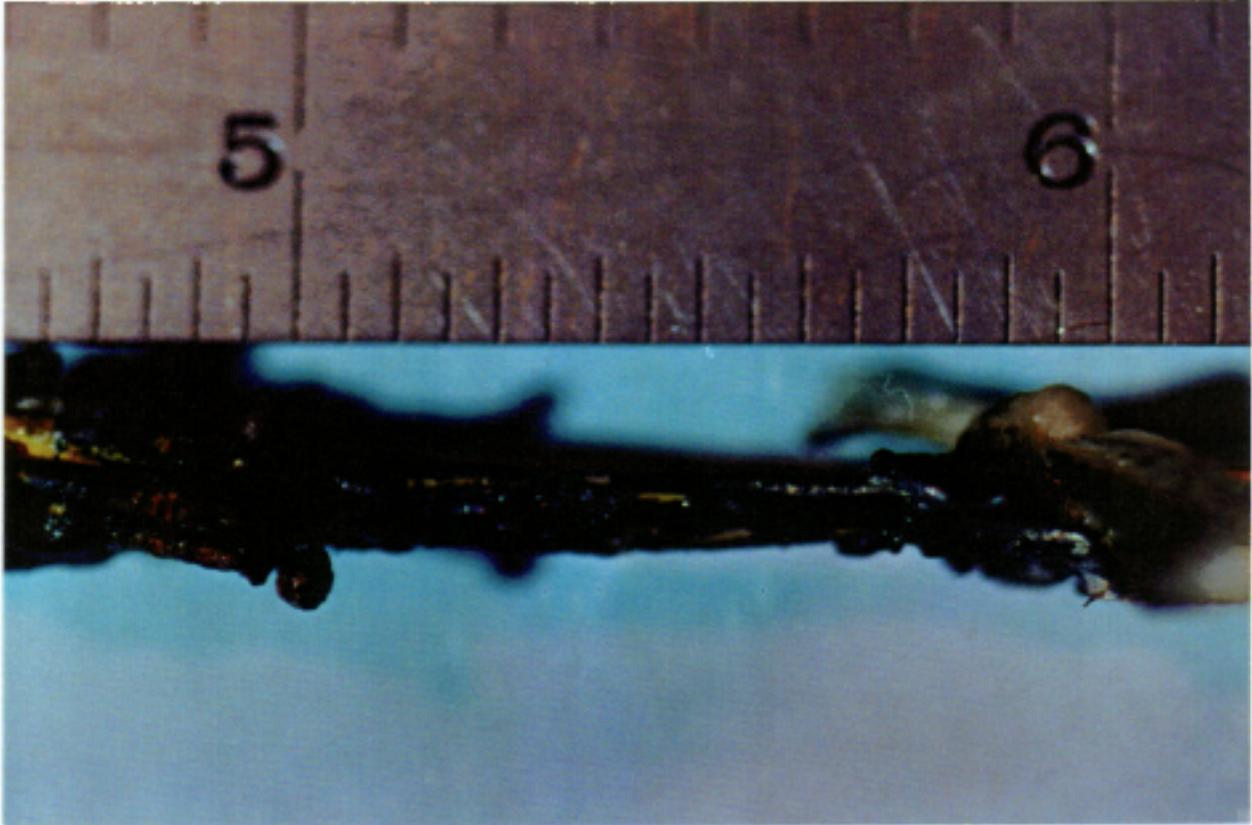
Examination of the sample after the test (Figure 26) showed that the damage and charring of the wire took place over a 2 inch span of the bundle and ~1 inch of the 5 active wires were eroded. All wires failed a wet dielectric test.

Figure 26. Test 3: Sample bundle after the test which included circuit breaker reset.

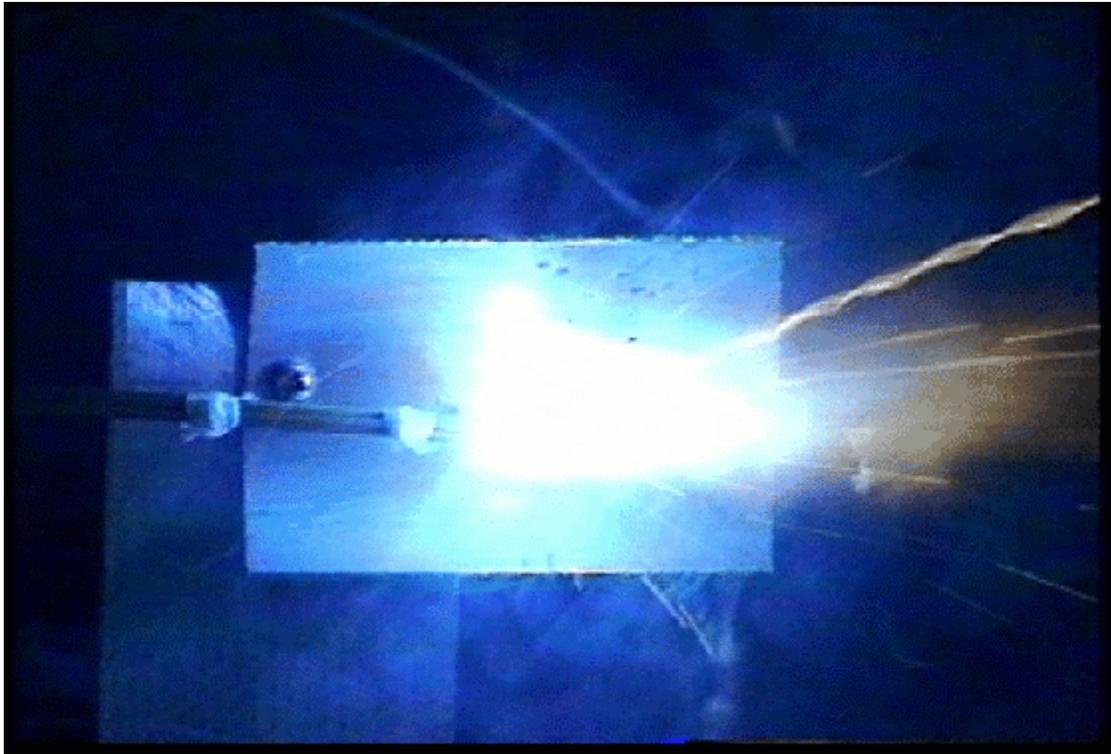
Both of the samples in Tests 4 and 5 had relatively short periods of scintillation followed by strong arcing (Figure 27) that damaged the other wires in the bundle and tripped several circuit breakers.

Figure 27. Test 4: Strong arcing on a Mil-W-81381/12-20 wire bundle

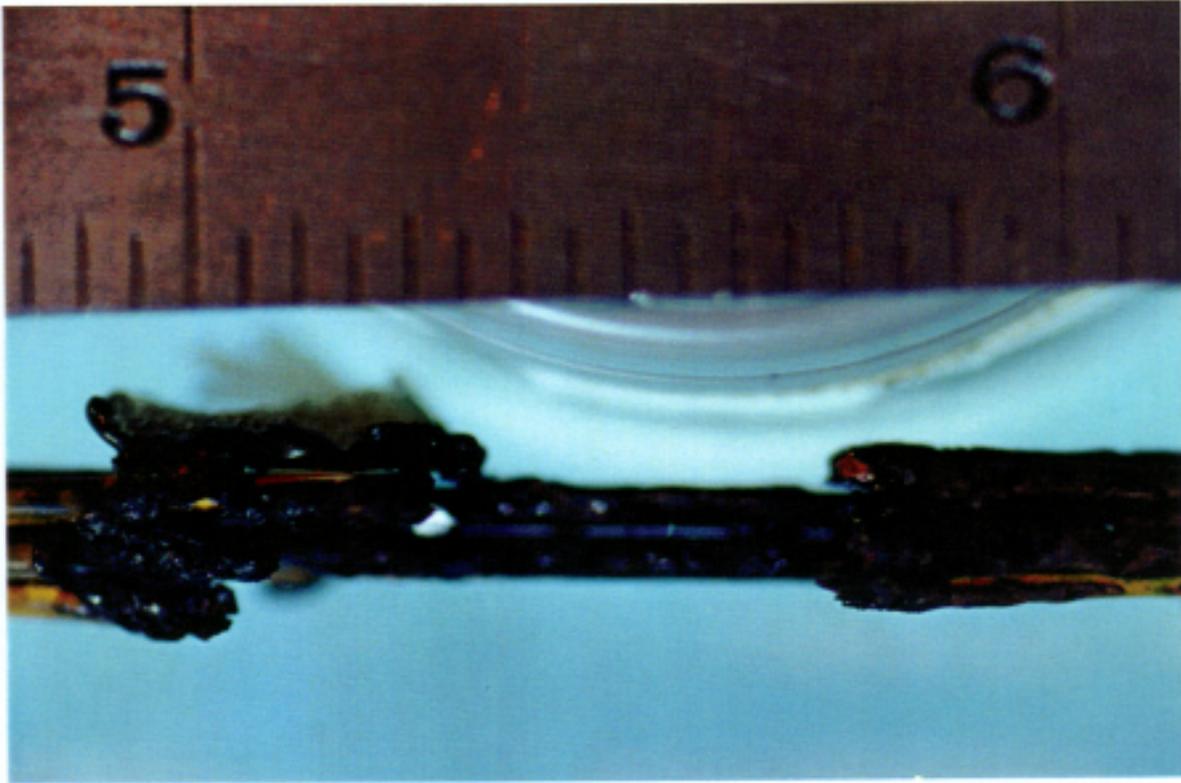
Examination of the bundles showed that the damage to the wire in Test 4 extended for about 2" and that 3/4" of the 5 active wires had eroded completely away (Figure 29). 4 of 5 wires failed a wet dielectric test. Because the circuit breaker was not reset, the damage to the wire in Test 5 was less than Test 4 with the damage only extending 3/4". Although each of the five active wires had been cut through by the arcing, the eroded length was only 3/8". Three of the five wires failed the wet dielectric test.

Figure 29. Test 4: Wire bundle after the test including two circuit breaker resets.

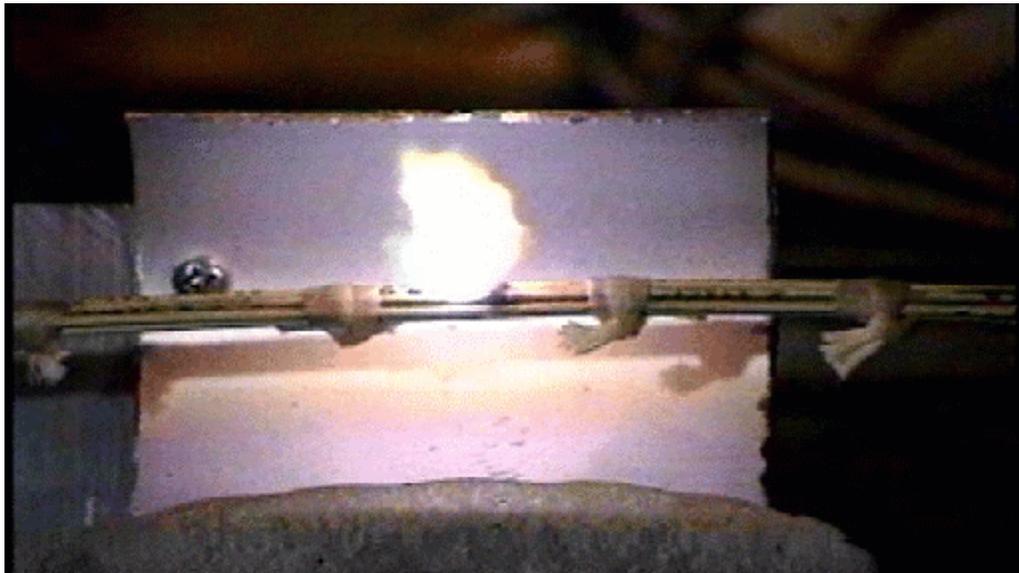
Figure 30. Test 6: Flash event during wet arc track testing with lavatory waste water.

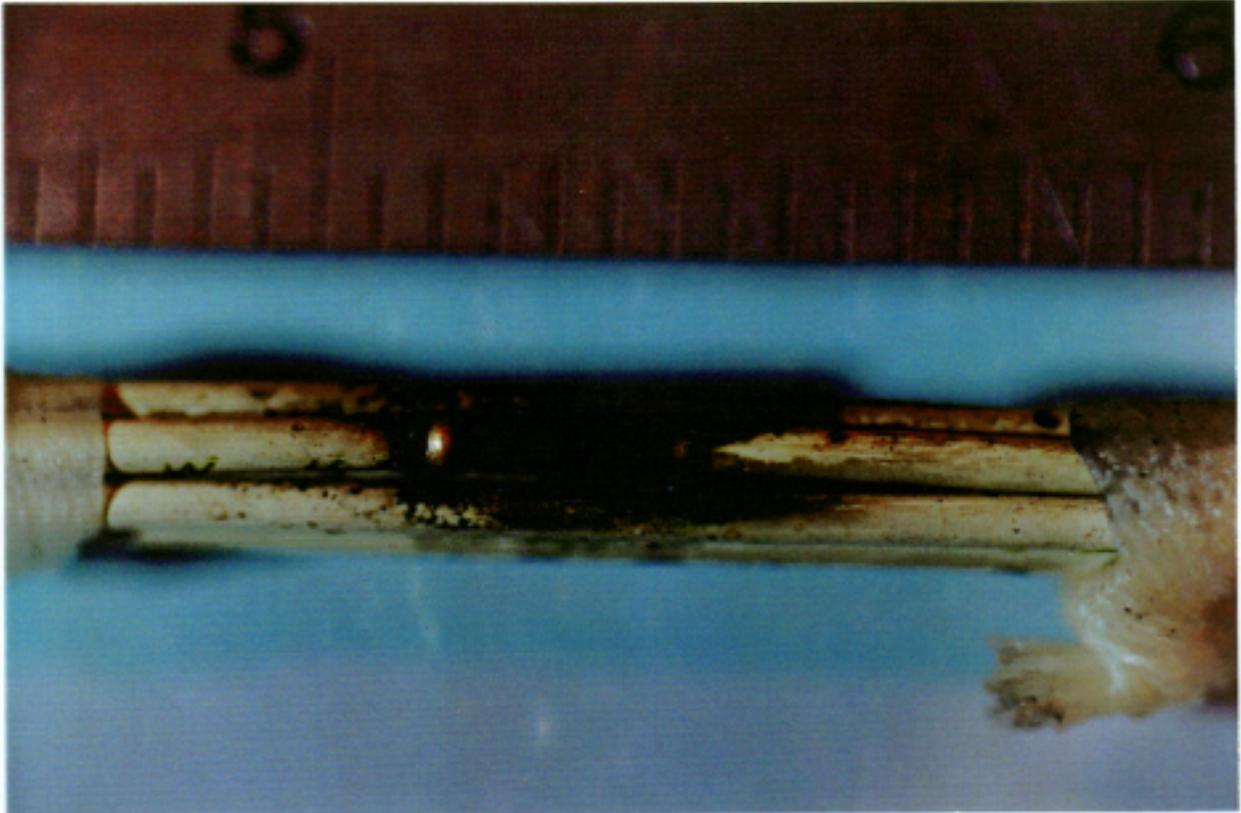
Examination of the bundles after the tests revealed the same type of as that found in Tests 1 and 2 but not to as high an extent, probably because these bundles were not tested as long (Figure 32).

Figure 32. Test 6: Sample bundle after wet arc track testing with lavatory waste water for 10 minutes.

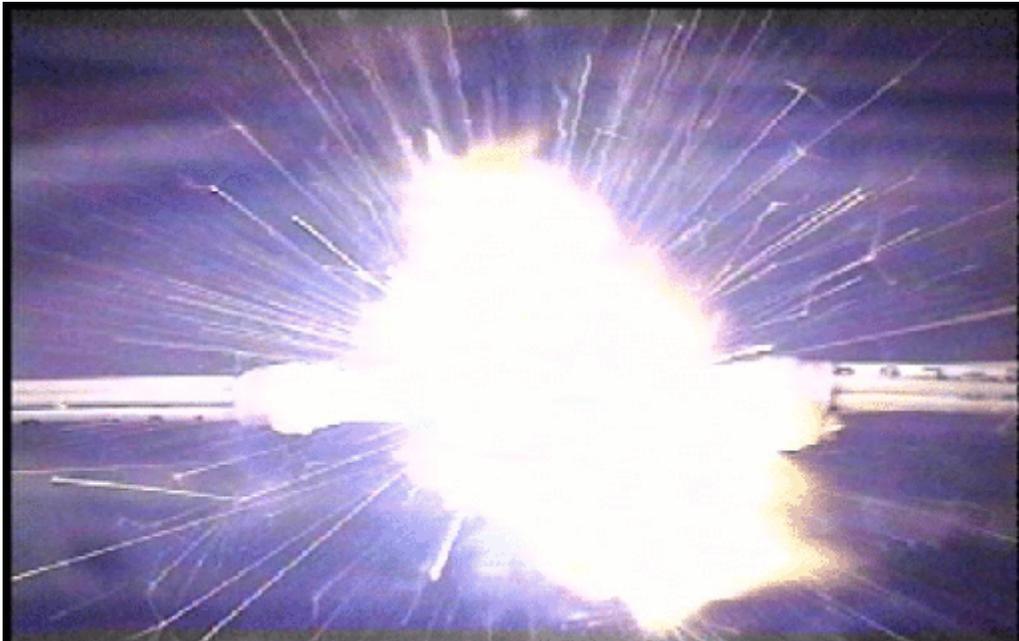
This test used the original arrangement with a single 7.5 amperes circuit breaker in series with each active wire. Application of power resulted in a flash (Figure 34) and the sample then became dormant. Soot was deposited near the pre-damaged cuts in the wire (Figure 35). No circuit breakers were tripped and one of five wires failed the wet dielectric test.

Figure 34. Test 12: Flash event during a metal shavings short circuit test.

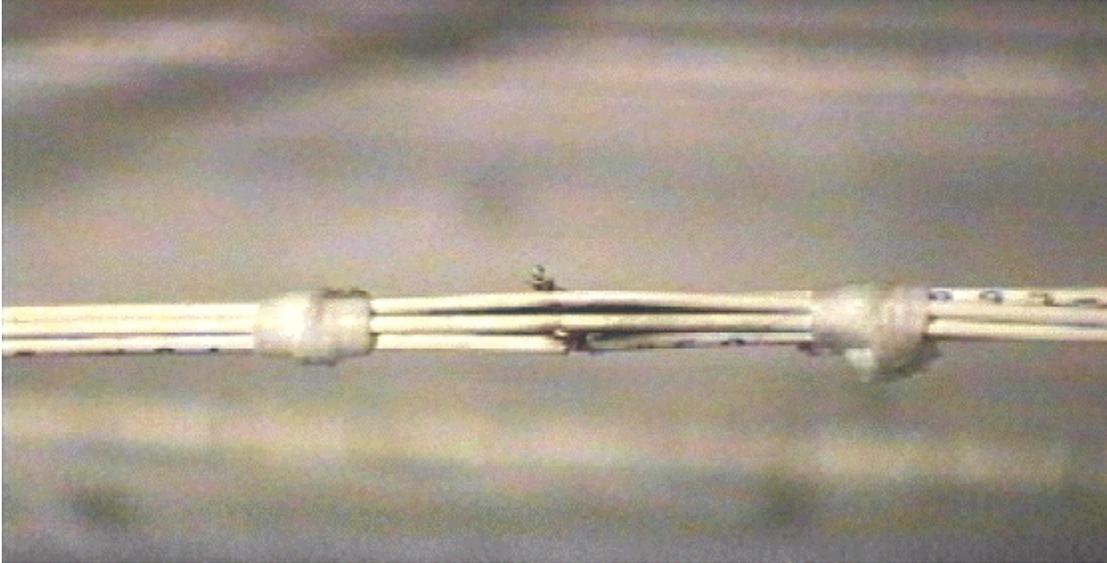
Figure 35. Test 12: Sample bundle after the flash shown in Figure 34.

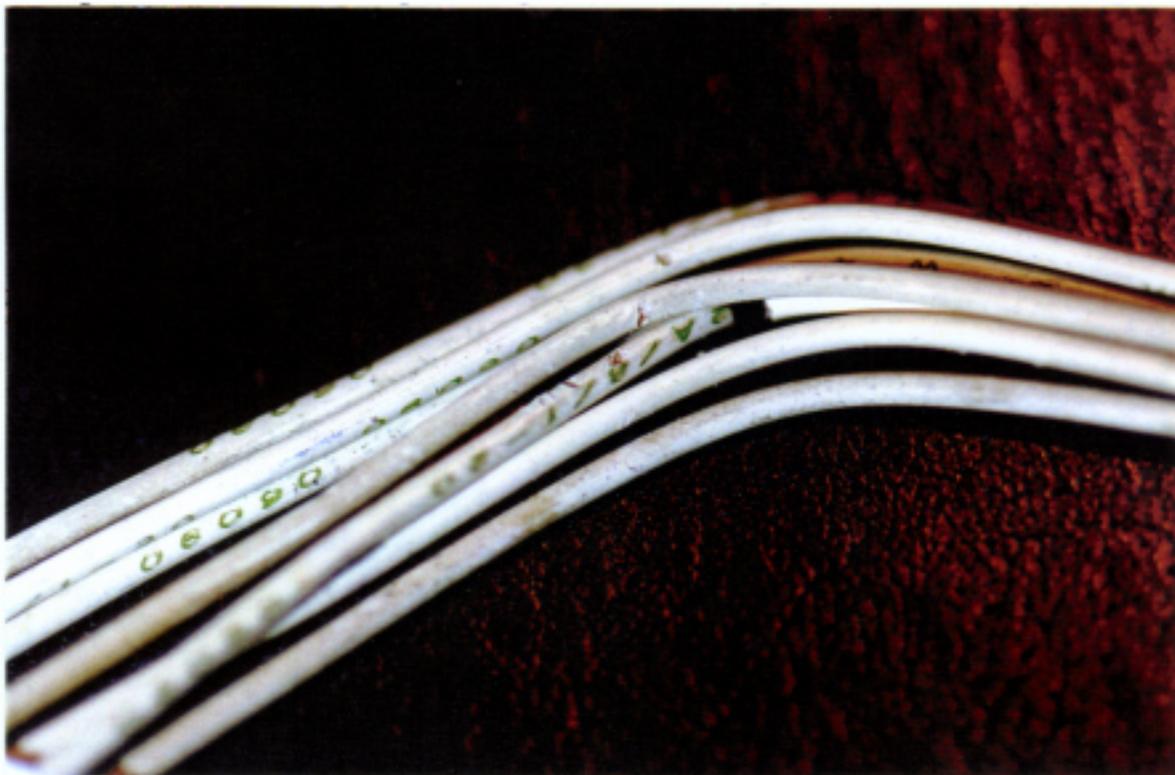
The flexing of the bundles did cause more severe damage in areas away from the shaving. In test A, one of the wire was broken completely in half. In test B, one wire was broken in half and the insulation on other wire cracked so that the conductor was exposed. These three wires failed the wet dielectric test while all of the other wires passed.

Figure 39. Test 16 A: Damage sample after metal shaving abrader 90° (right angle) test.
Note that the broken wire was due to flexing and not the action of the shaving.

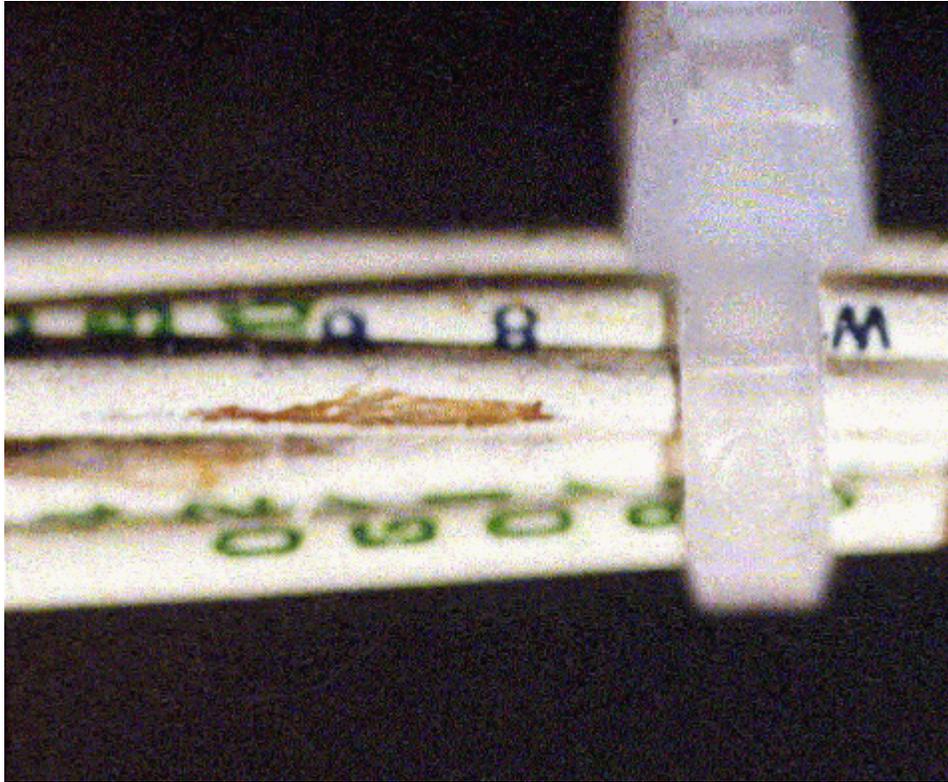
Figure 40. Test 17: Abrasion damage that did not reach to the conductor.

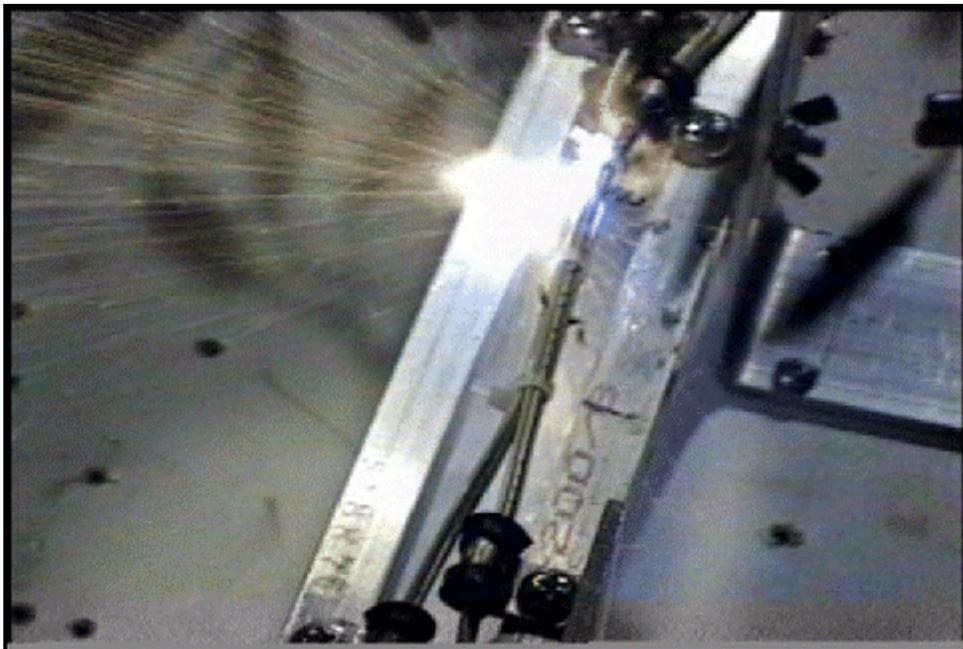
Figure 41. Test 17: Flash event during the longitudinal abrasion test.

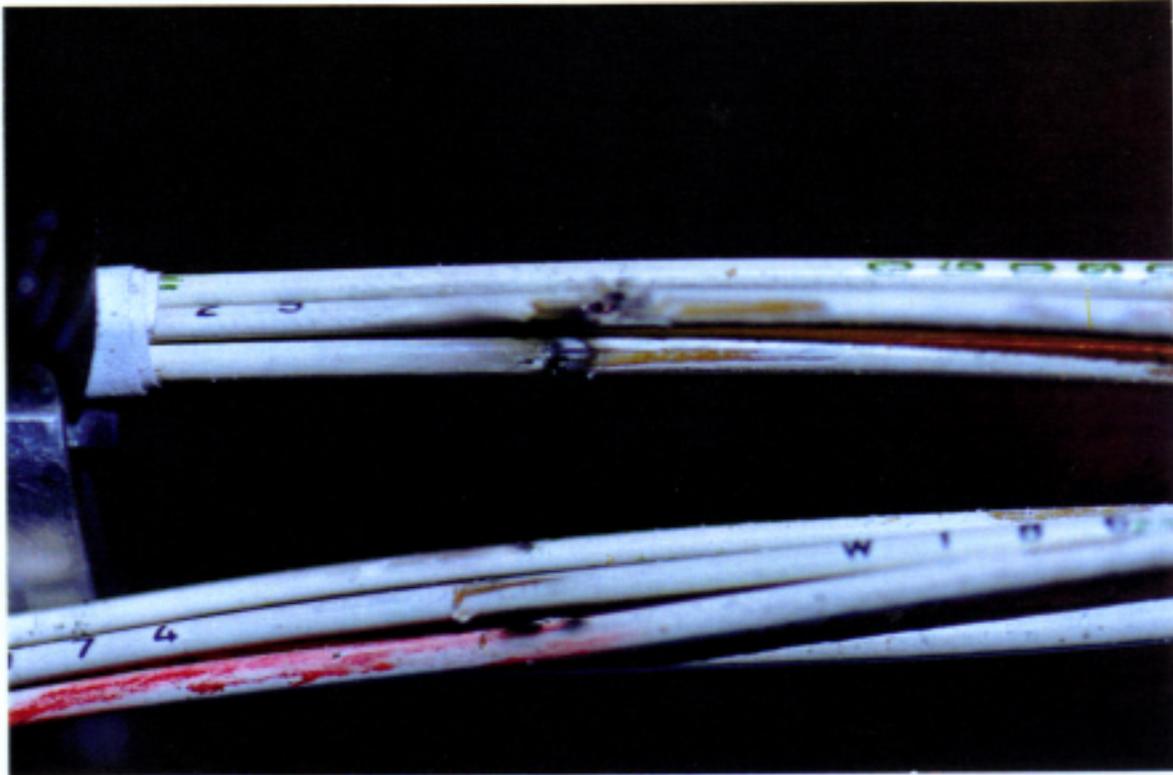
Figure 42. Test 17: Damage to wire bundle in the area of the flash.

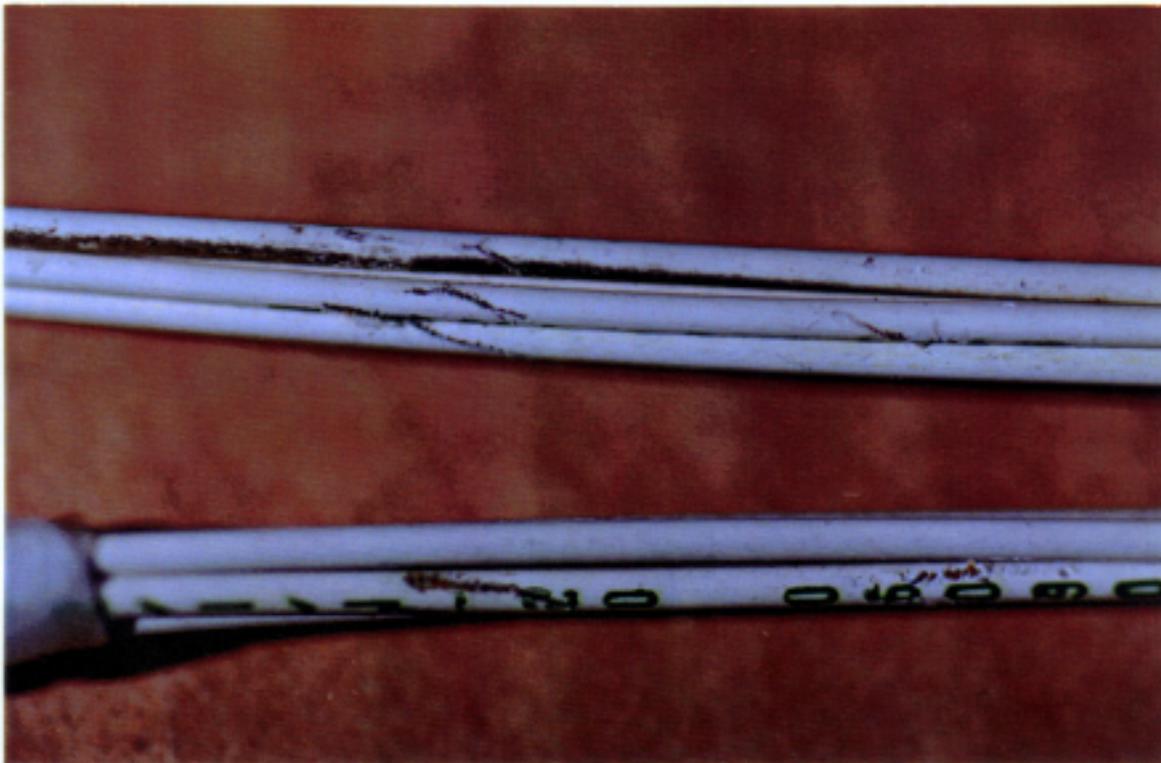
In Test 19 the shaving used was thinner (49 mils by 18 mils) and the abrasion patterns were more like short cuts in the insulation (Figure 43). There were no flashing events during the 4 hour duration of the test. However, two of the eight wires failed the wet dielectric test. The points of failure on these wires were at cuts that were deeper than they first appeared. From the location of the cuts it appears that different shavings made the cuts and therefore they could not cause a flash event.

Figure 43. Test 19: Cut damage to the insulation which in some cases reached to the conductor.

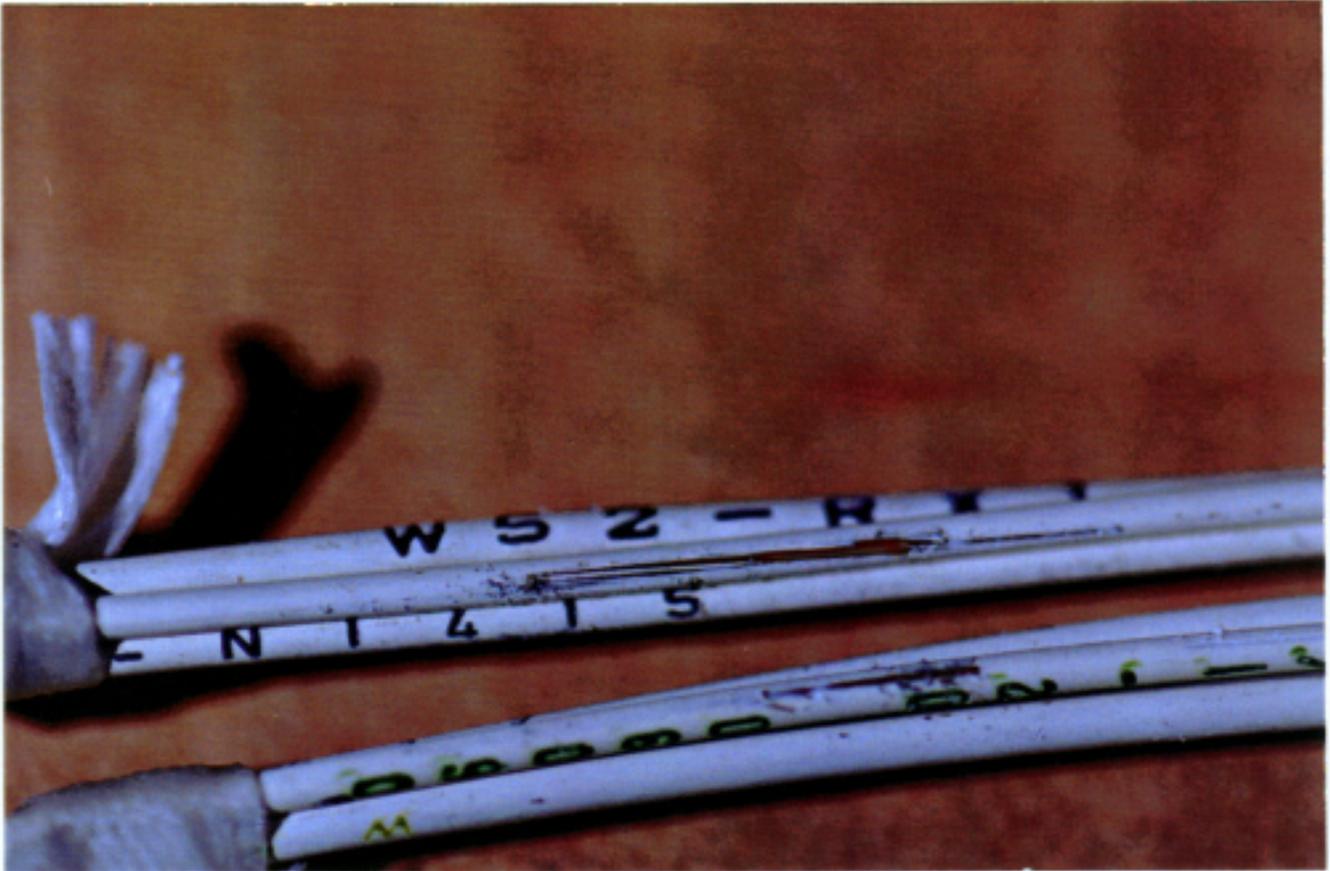
Damage caused by the shaving was mainly limited to the topcoat with some superficial damage to the Poly X layer (Figure 44). If the test was allowed to run longer it is possible that the shaving may have eventually abraded through to the conductor. However, in general when an aluminum shaving got into a position where it was forced into the insulation, it tended to break and was no longer an abrasion threat.

Figure 44. Test 20: Damage done in longitudinal abrasion tests with aluminum 7075 shavings
